LMSC-HREC TM D784644

STUDY OF NSI AND RELATED  
CABLE PERFORMANCE DURING  
TESTS PERFORMED IN THE  
NASA HOT GAS FACILITY

January 1982

This report documents the tests performed on various cable configurations to evaluate the Nozzle Severance, Insulated (NSI) and other cables inside the Space Shuttle Solid Rocket Booster (SRB) aft skirts. The work was performed under Contract NAS8-32982, "Solid Rocket Booster Thermal Protection System Material Development." The NASA Contracting Officer's Representative for this work is Mr. Bill Baker, EP44.

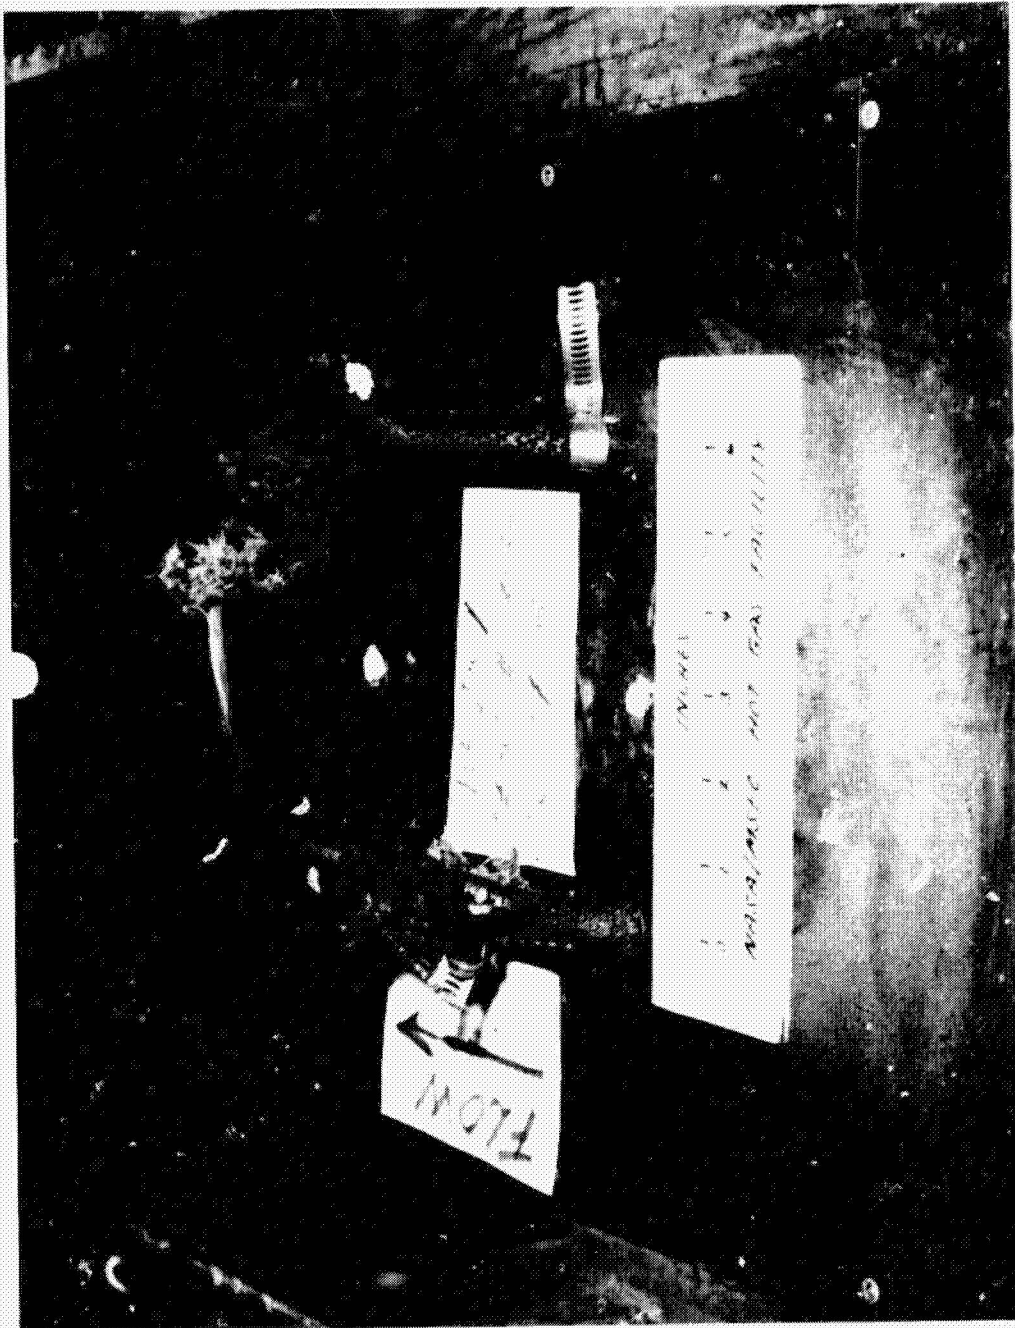
The cable test models were built on test panels and all, except one, were mounted in Test Position 1 of the Hot Gas Facility test section where the clean body heating rate is the lowest attainable. A typical cable loop model is shown in Fig. 1. It consists of a length of flight cable with a clear plastic sheathing which is layed on a length of cable wrap material called "Blastape II." This tape is simply folded over the cable along its length and this arrangement is mounted on a base plate by means of hose clamps as shown in Fig. 1. The model was subjected to 60 seconds of cold flow during which no damage to the cable or its wrap was apparent. It was then subjected to 6.03 seconds of hot flow which failed the insulating Blastape and exposed the cable as shown in Fig. 2.

Fig. 2 - Post-Test Photograph of Cable Loop Model

- The "Blastape II" is a good cable wrap material but when wrapped on the cables or connectors needs to be clamped securely so that it cannot slide off the cable.

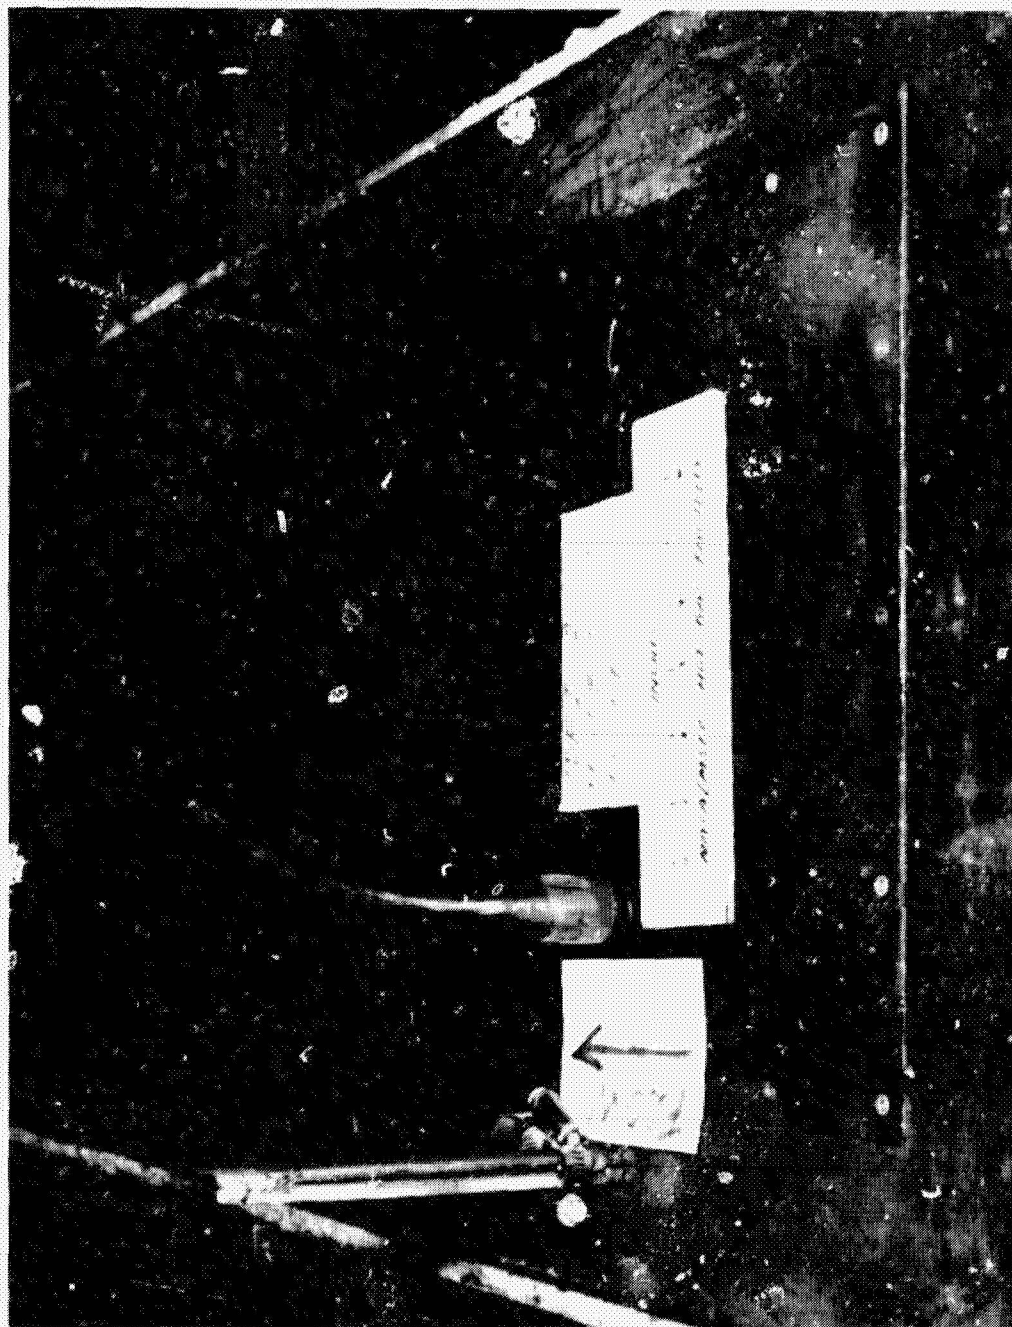
Figure 3 shows a short length of flight cable and connector, both wrapped with Blastape. The tape is wrapped spirally around the connector first and then on to the cable with at least a 50% overlap of the tape material. The connector is mounted in the base plate and the other end of the cable is fastened to a small vertical bracket. This model was also exposed to 60 seconds of cold flow and then 6.04 seconds of hot flow. It is theorized that the top end of the cable broke loose first allowing the cable to flap in the flow and thus causing the entire wrapped material to be lost at once (See Fig. 4). Another model of the same configuration was made up with the end of the cable fastened more rigidly as shown in Fig. 5. The results, however, were similar as shown in the post-test picture of Fig. 6.

Fig. 4 - Post-Test Condition of Model (Fig. 3) Indicating Loss  
of Grip on Top End of Cable and thus Loss of Wrap Material

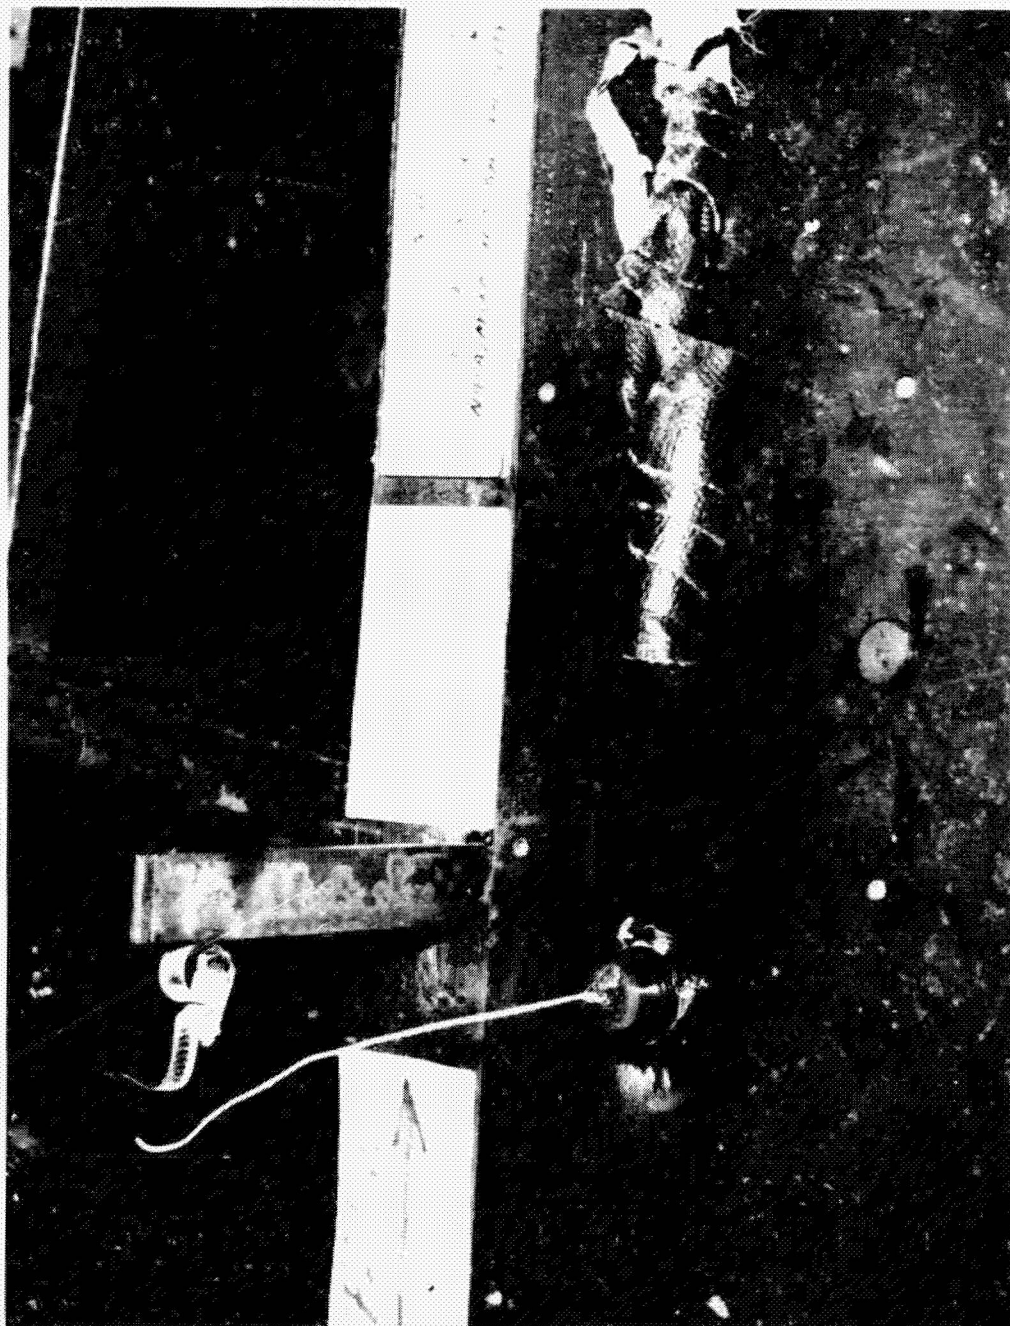
Fig. 6 - Post-Test Condition of Cable with Results  
Similar to Specimen Shown in Fig. 4

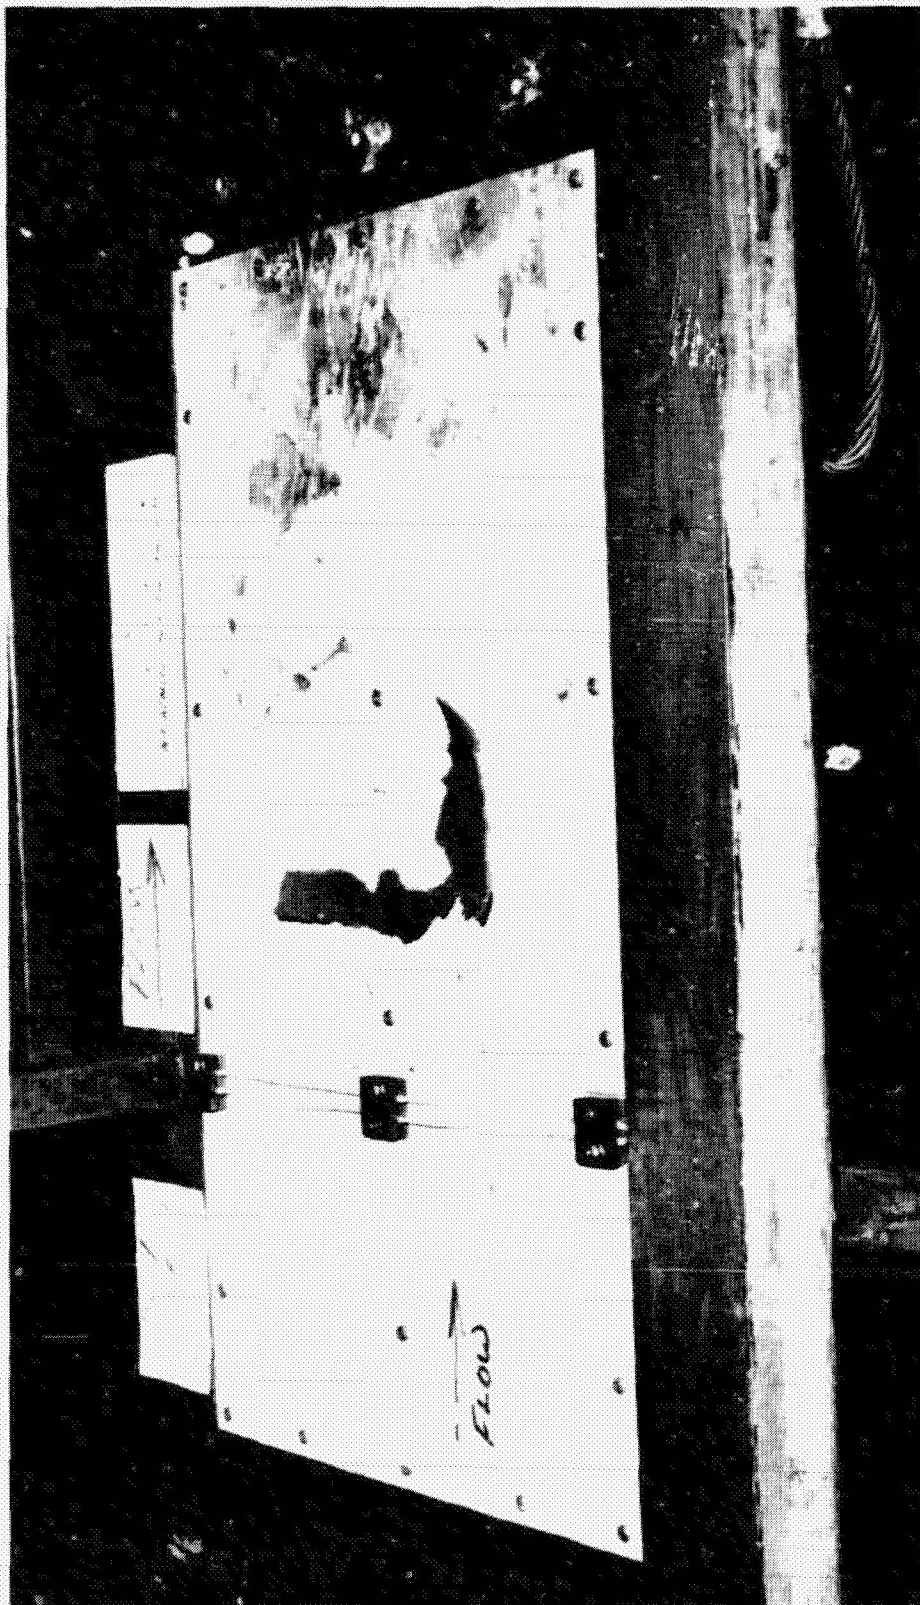
a representative distance apart on a flat aluminum panel partially protected with cork. After 26 seconds of test, when the run had to be terminated due to aluminum temperature directly under the cables having reached 400 F, all cork was lost (probably due to faulty bond). The cables looked good but were sagging a little as seen in Fig. 8. This test was repeated and results were the same as far as cables were concerned (see Figs. 9 and 10). Yet another repeat run was made with the exception that the aluminum backface temperature was allowed to rise above 400 F in order to obtain a longer test duration. The result of this test which lasted 50.3 seconds is depicted in the photograph of Fig. 11 where one portion of cable was lost and another was loosened.

Fig. 8 - Loss of Cork Indicated Due to Improper Bonding  
(Note Sagging Cables)

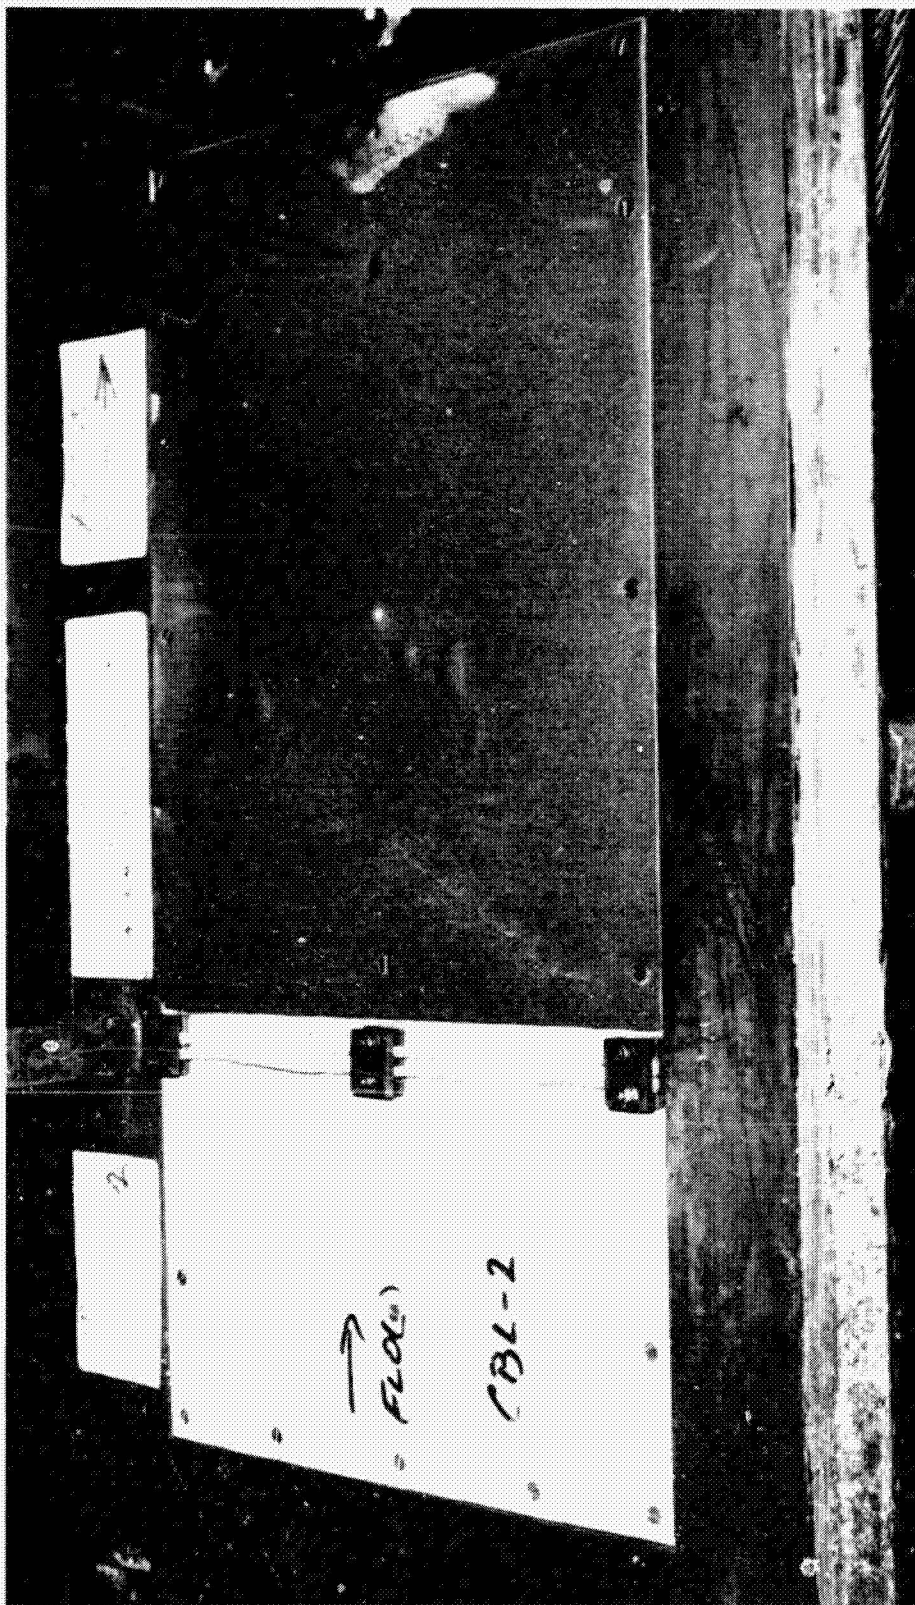
Fig. 10 - Results of Test on the Cables Mounted on Panel are Similar  
to Those on an Identical Test Setup of Fig. 8

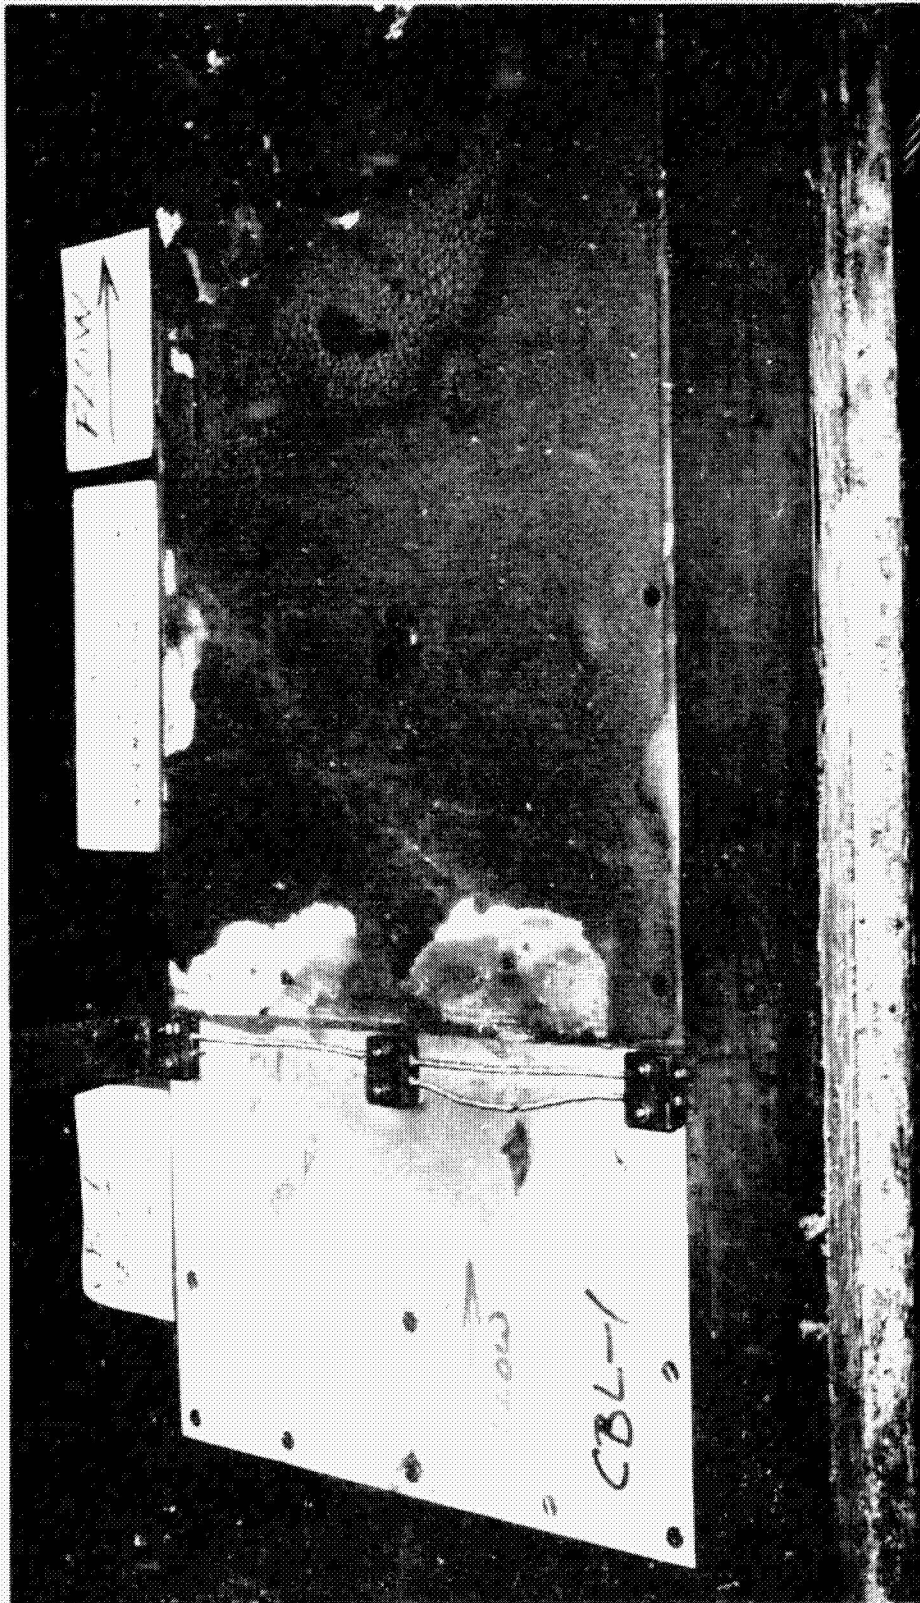
Fig. 11 - Test Duration on This Cable Test Model was Longer  
Than on Previous Two Models of Figs. 8 and 10  
Causing Cable to Break

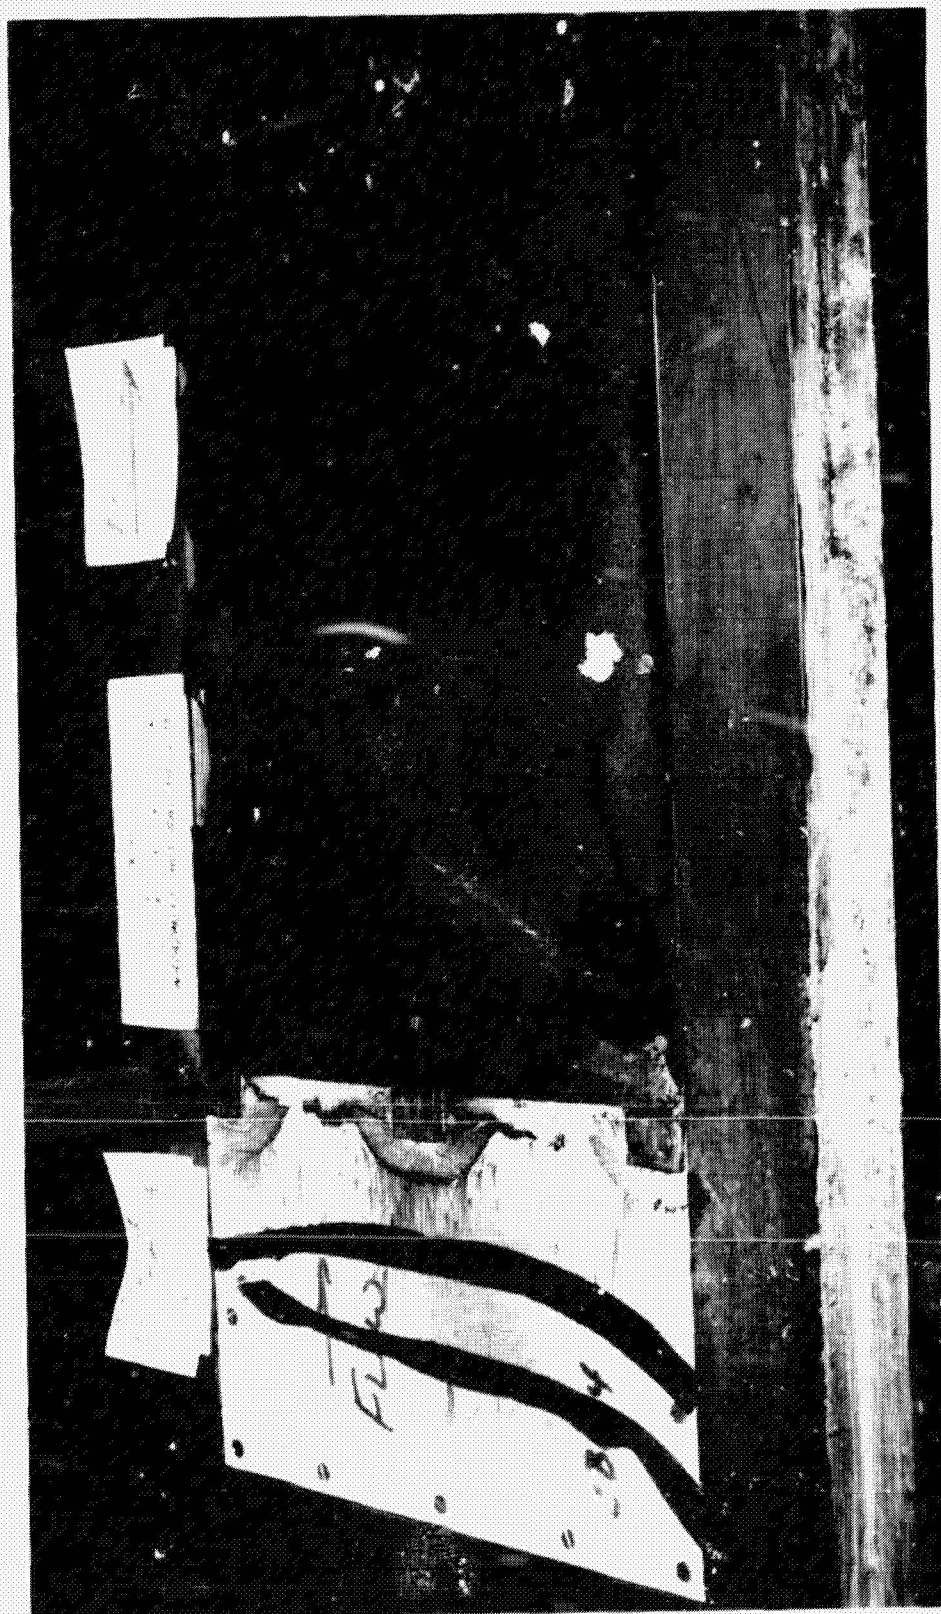
Figure 12 is also a cable model similar to the one shown in Fig. 9. Here the cables are wrapped individually with "Blastape II" and fastened with nylon ties that are bonded with EA 934 to small steel plates bolted to the aluminum base. A post-test picture of this model is shown in Fig. 13. The two cables shown here were recovered later after the test. The clamps could not be found and are believed to have disintegrated due to the heat early in the test which was run a full 60 seconds (maximum run time in HGF). In order to find a solution to the problem of proper cable mounting technique, the model of cables with Blastape and nylon ties was taken and a ramp of K5NA closeout material was built up over the cables as shown in Fig. 14. This model was run for 60 seconds also and virtually no damage, aside from the normal char formation, was indicated.

Fig. 13 - Nylon Ties Seen in Fig. 12 Failed Losing Hold on Cables  
Which Were Later Retrieved

- The nylon cable ties used to clamp the cables are not suitable when they are exposed to the hot flow.
- Bare cables should not be exposed to hot aerodynamic flow, for they will surely fail.

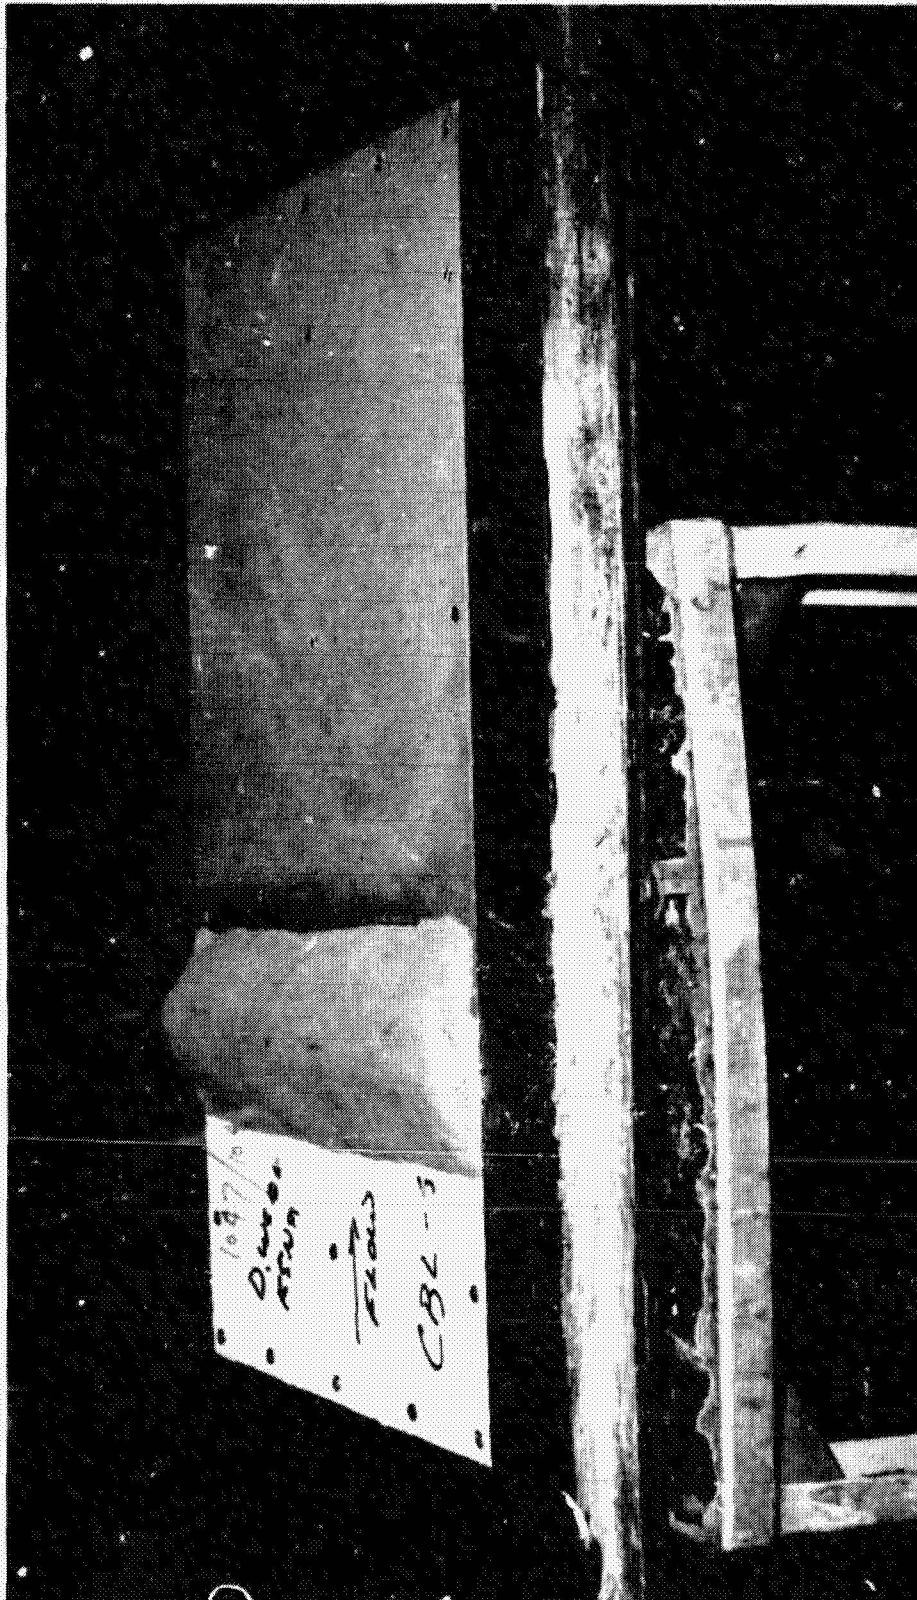
The cable test model of Fig. 14 had two thermocouples on the back side of the panel and under the K5NA ramp. These thermocouples recorded maximum temperatures of only 142 F since they were located directly under the hump of the K5NA material. The temperature of the bond line between the K5NA and the aluminum panel would be higher at the start of the ramp. It was necessary to know the maximum bond line temperature attained during the 60-second test to aid in establishing the upper temperature limit for the bond between K5NA and the aluminum. Additional thermocouples were installed for this purpose on the previously tested panel of Fig. 14. The panel was rerun for about 28 seconds only, since the bare aluminum in front of the panel reached 480 F and the run had to be cut. The thermocouples under the panel where the ramp started read 350 F at the end of the run and post-test inspection of the panel showed no signs of debonding between the K5NA and the aluminum base plate.

Fig. 14 - Cables and Ties Shown Covered with K5NA Closeout Material  
(To Ensure Against Cable Loss)

- Cables and their fastening devices when protected with K5NA closeout materials will not fail and the K5NA will not debond from its applied surface when the surface gets to at least as high as 350 F, perhaps higher.

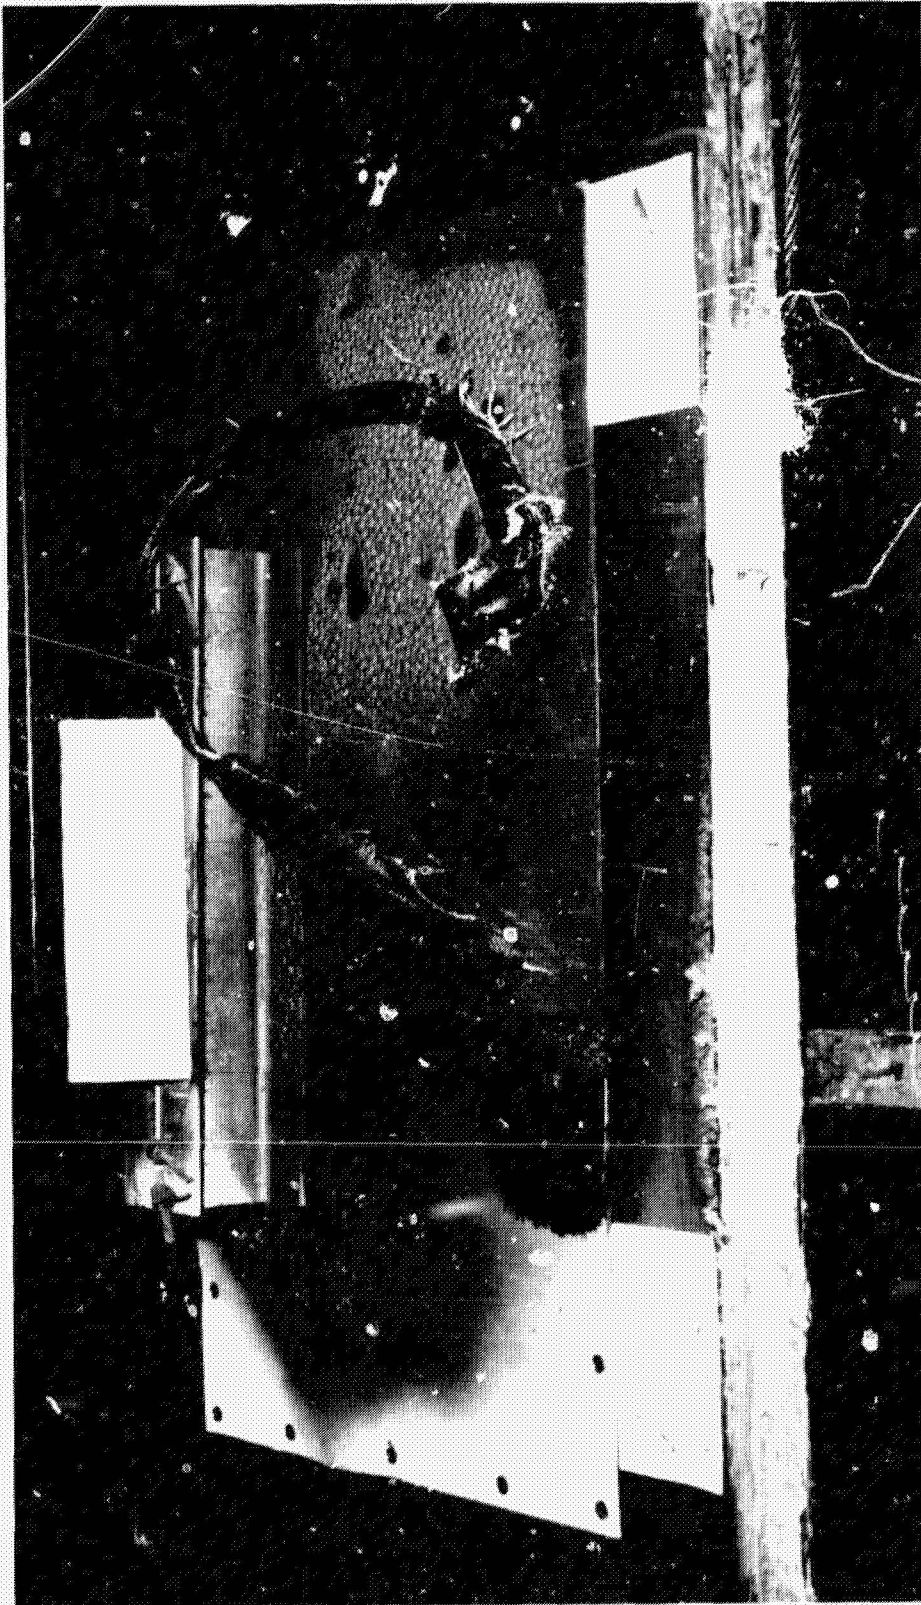
Figure 15 is a photograph taken from inside the aft skirt of A-11 showing a cable routed in a U-shape over the aft skirt aft-ring. This cable configuration is the subject of the next test model shown in Fig. 16. The cable as seen is wrapped with "Blastape II" and routed on the test panel in the manner shown in Fig. 15. It is fastened with nylon ties threaded through nylon bases bonded to the test panel with EA 934. The cork on the downstream half of the panel is to protect the aluminum base plate in the higher heating rate region in the HGF. The cable was lost during the test again because the nylon ties could not withstand the heating. These ties, broken in pieces, are shown in Fig. 17 with the relatively undamaged cable recovered after the test.

Fig. 17 - Loss of Cable is Indicated Due to Failure of Nylon Ties  
Used for Fastening Cable

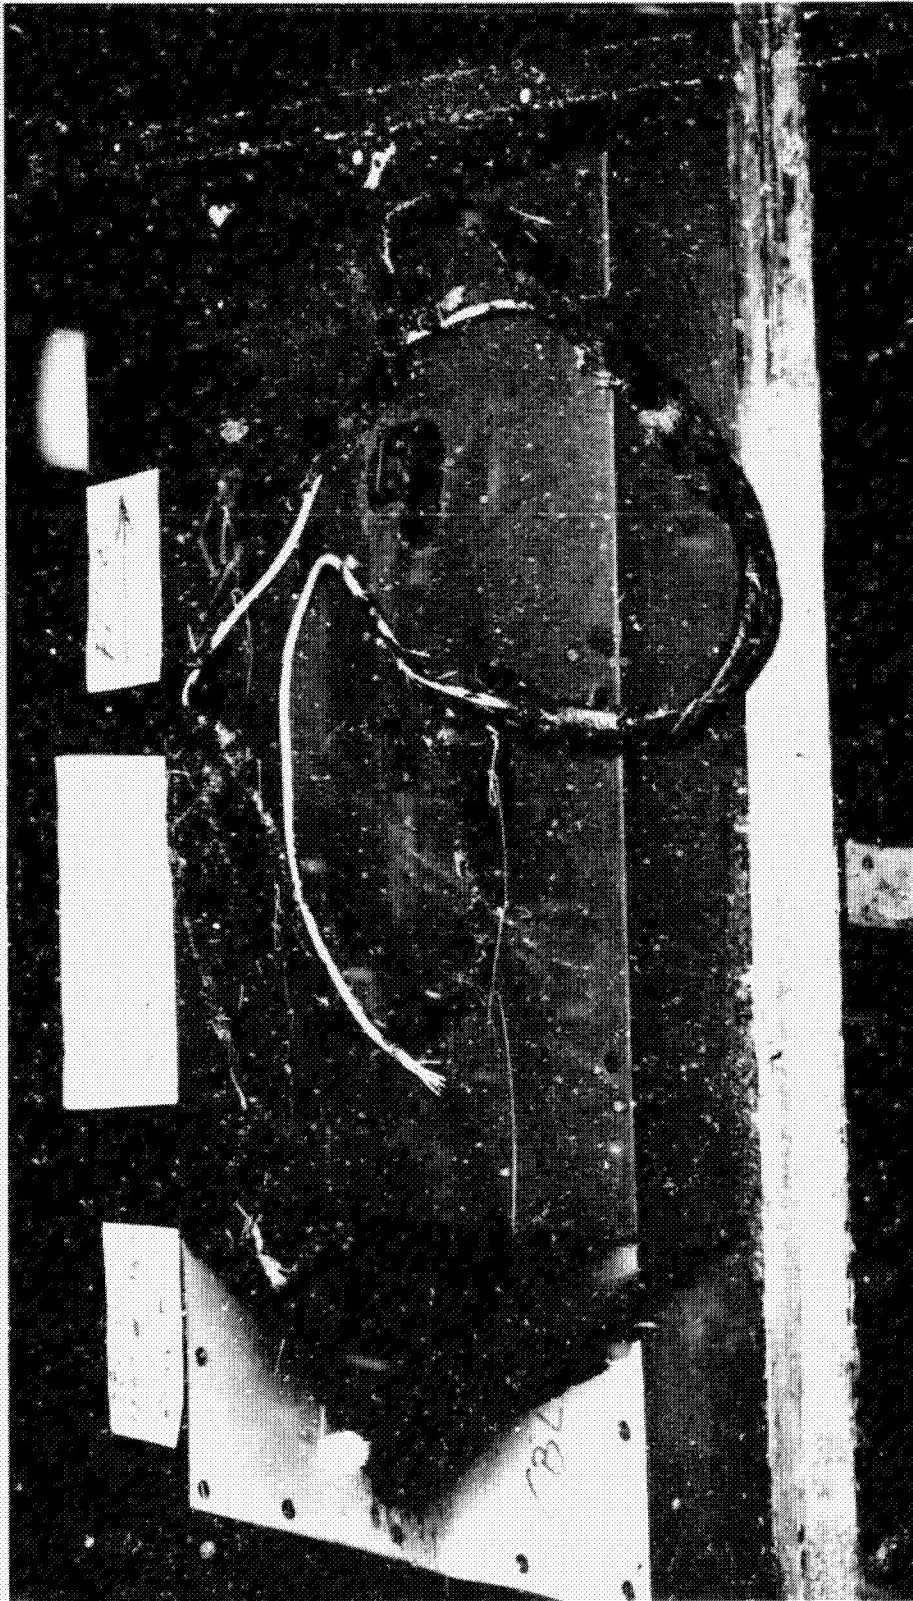
Aft skirt rerouting cables are depicted in the photograph of the inboard surface of A-12 in Fig. 18. This type configuration of cables including the mounting ties and typical spacing between ties was simulated with a cable model built on a flat test panel. Post-test photographs of the model shows that the cable came loose completely from its clamps, a problem encountered in earlier tests (see Fig. 19).

Fig. 19 - Post-Test Condition of Test Panel Prepared to Simulate Typical  
Cable Routing Shown in Fig. 18

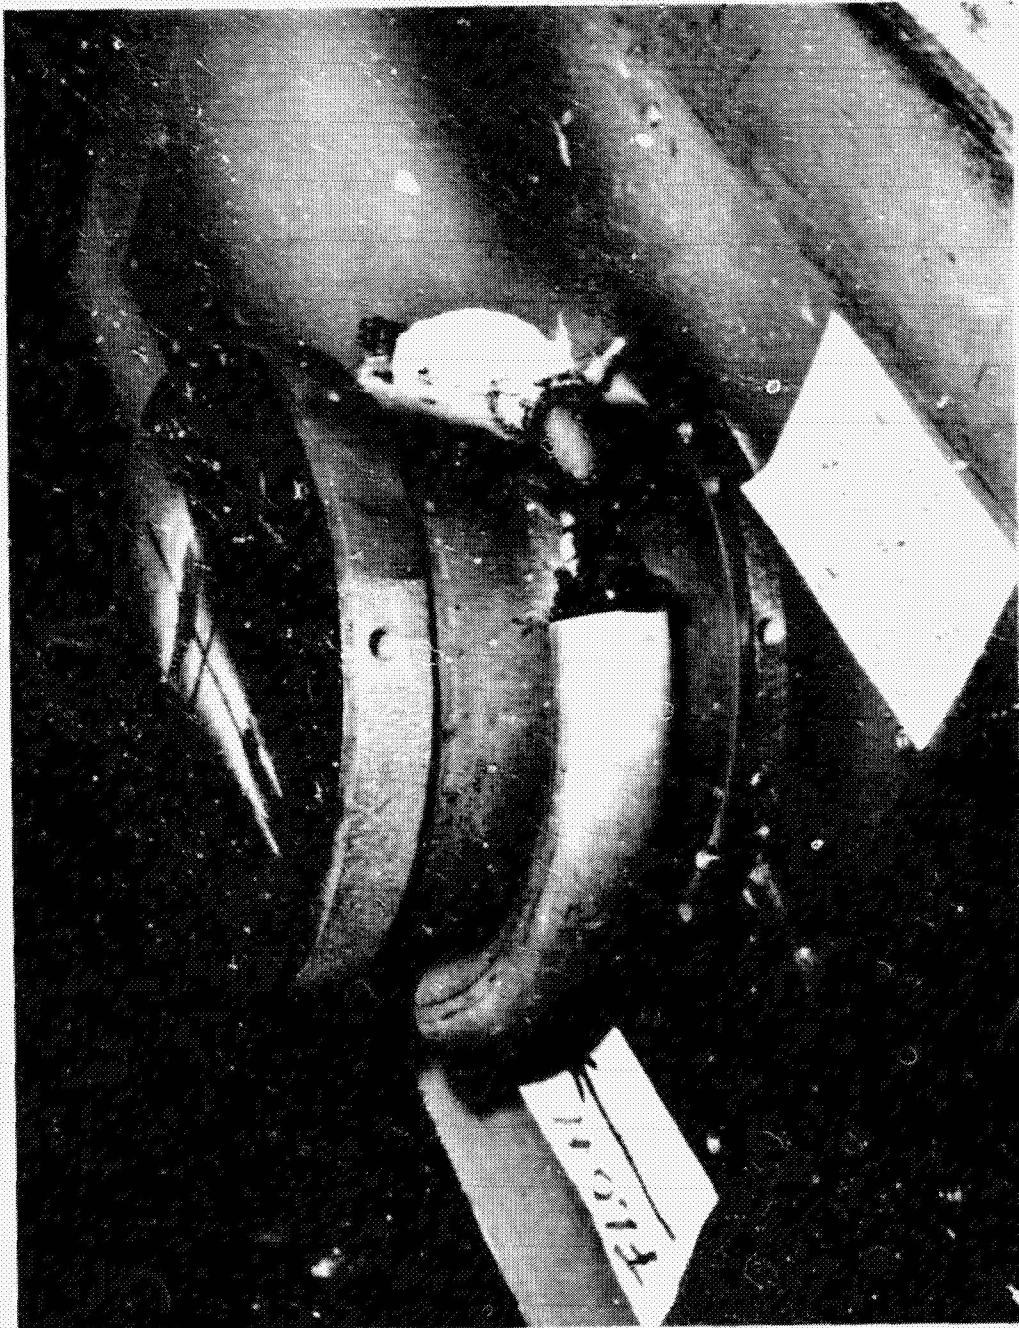
An alternate cable wrap material known as "3M Heat Barrier Tape SJ8000X" was tested. The 3M tape is a very pliable, easy-to-wrap tape as opposed to the thick and hard to spiral wrap "Blastape II." The 3M tape had been tested earlier during the strut cable wrap materials evaluation test program and had failed; so it was believed that two layers of the 3M tape and one additional layer of aluminum foil tape (Specification No. STW4-2543), both spiral wrapped with at least 50% overlap to render a total of 6 layers over the cable, would be adequate. This cable wrap was tested under identical conditions as were the other materials during the strut cable evaluation test program. The test model shown in Fig. 20 was mounted in Position 4 of the HGF test section. The temperature of the surface of the cable reached 300 F in 12 seconds and the test cable was destroyed (see Fig. 21) before the run was terminated at 14.8 seconds.

Fig. 21 - Front/Side View of Model After Test Showing the Exposed Cable Which was Wrapped with 3M Heat Barrier Tape

- The 3M Heat Barrier Tape, though easy to wrap cables with, is not as good as the "Blastape II" for thermally protecting the cables.
- Cables when buried under 3 in. of "Instafoam" would survive the heating predicted for thermal curtain failure, though it is not known how well it would take the aerodynamic and aero-shear forces.

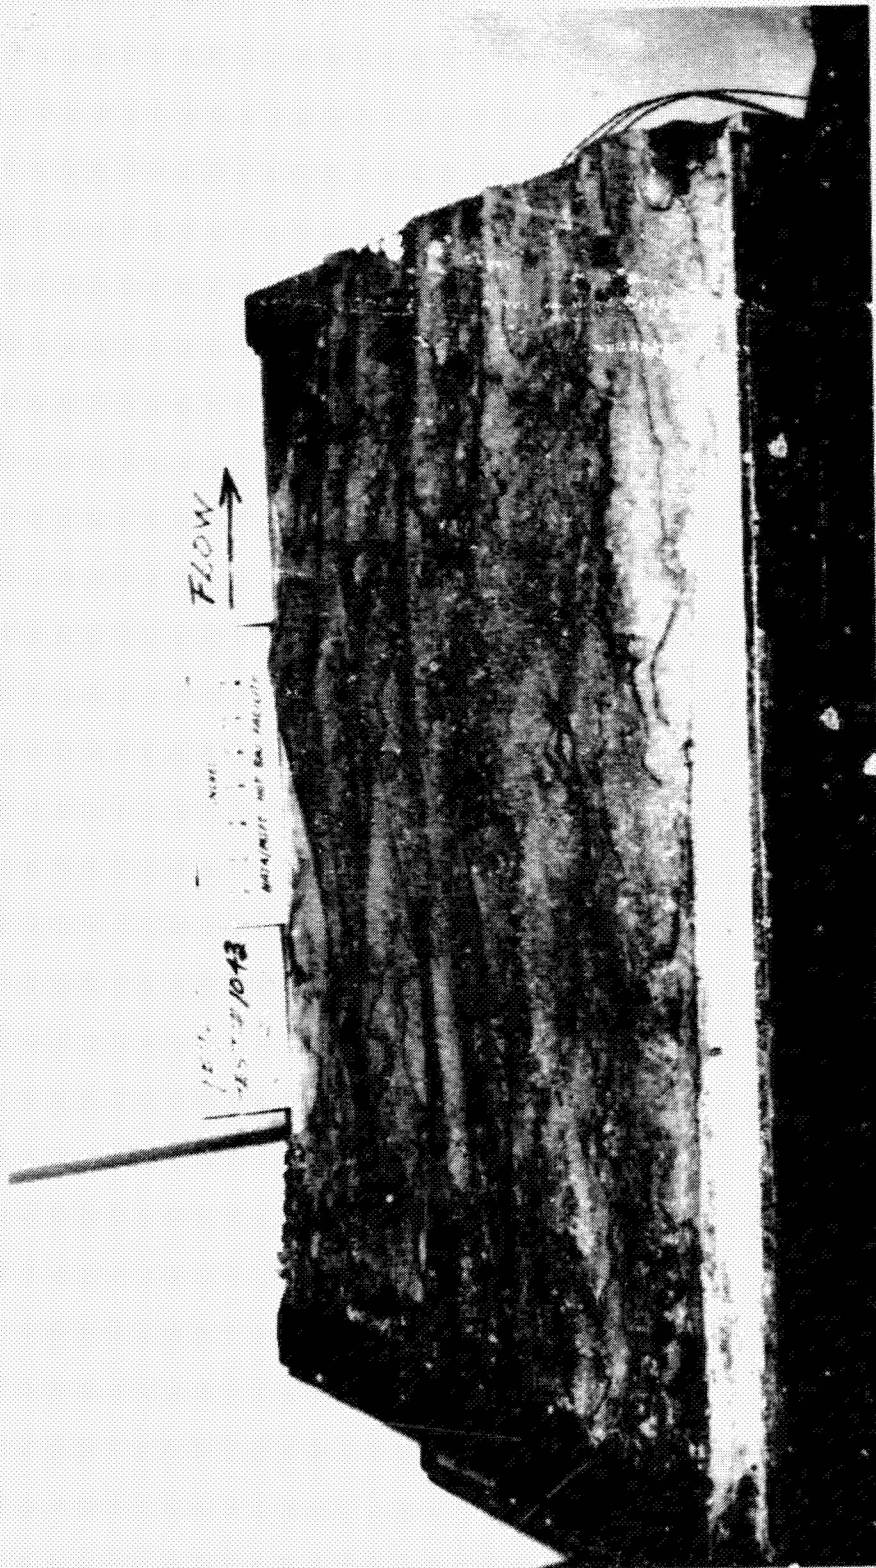
Figure 22 shows a ramp of "Instafoam" made up in a 3 in. deep steel pan that is 28 in. long and 22 in. wide. The pan carries assorted cables at its bottom, with a thermocouple attached to each one, buried in the foam. The pan was mounted in Position 1 of the HGF test section where the average heating rate on the ramp is estimated to be 11 Btu/ft<sup>2</sup>-sec. Fig. 23 shows the condition of "Instafoam" after 77 seconds of hot flow over it. The thermocouples did not respond since they were buried deep in the foam.

Fig. 23 - Condition of Insta-Foam Material After Test Lasting 77 s :  
in Position 1 of Hot Gas Test Facility
